TEST RESULTS 1st SELF HEALING PERIOD

PROJECT REPAIR TOP DECK CRUISE PIER

With Self-Healing Concrete Solutions

Project no.: BC-2021-001

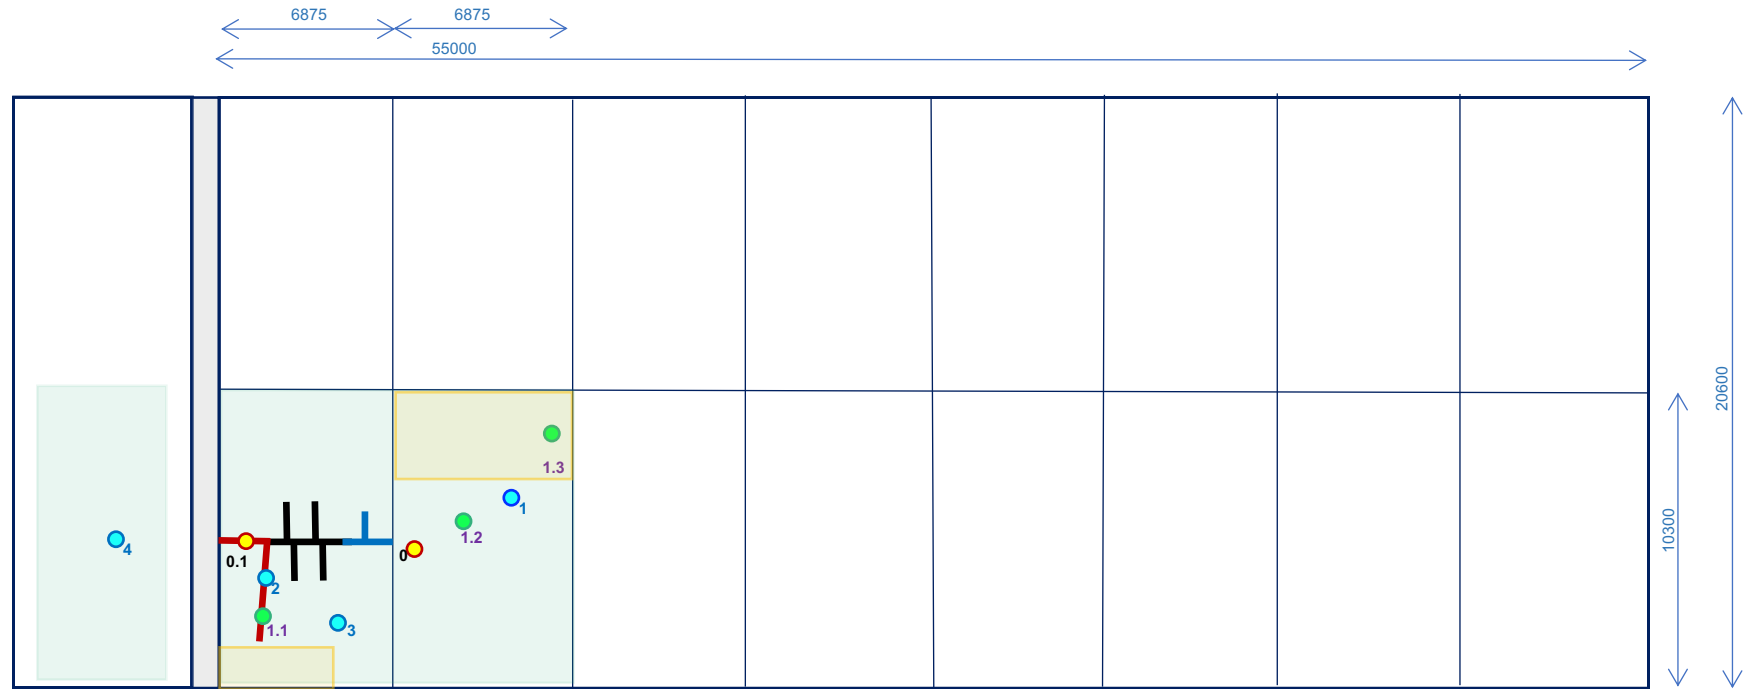
TEST LOCATION OVERVIEW

- M3_30 - 60mm Repair + ER7 treatment
- M3 Repair_30mm
- M3 Repair_20mm

ER7 Surface treatment

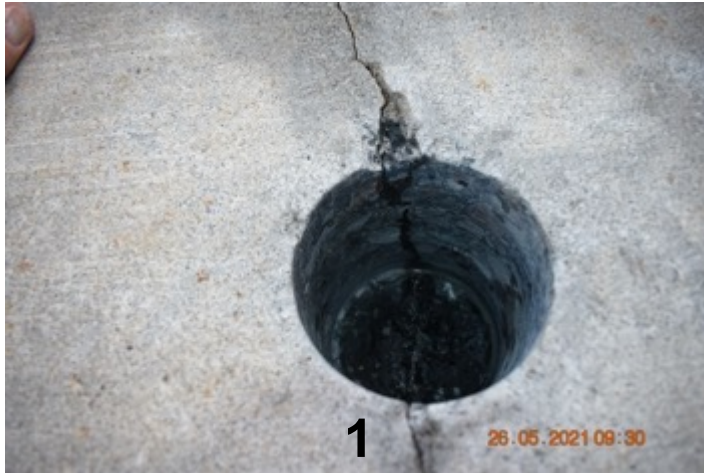
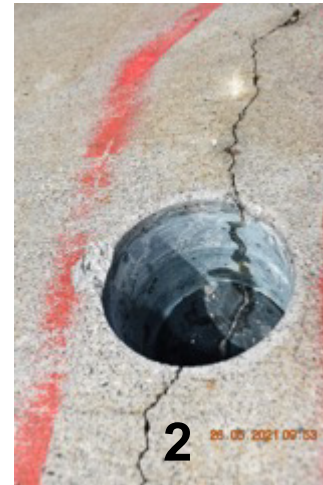
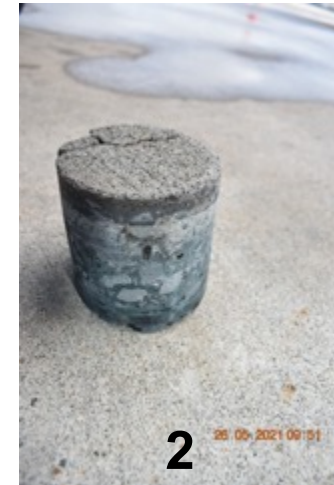
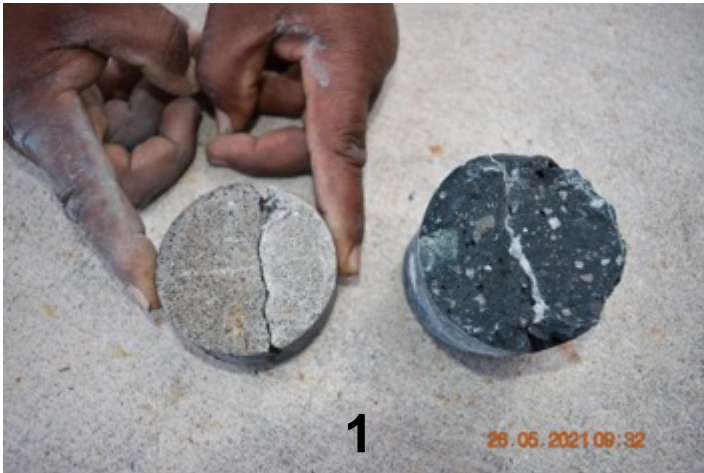
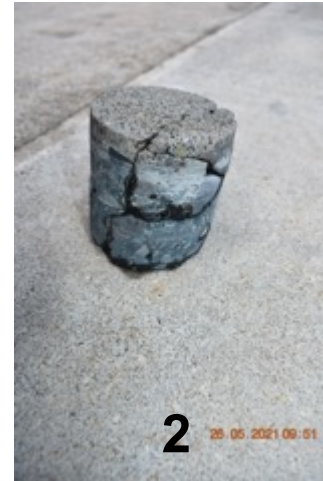
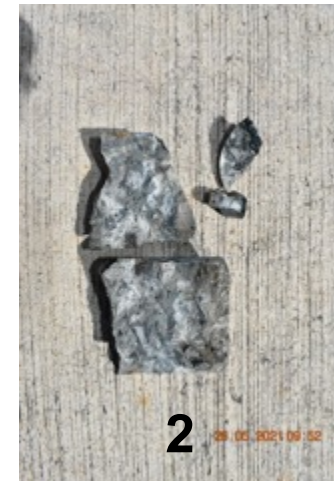
TEST RESULT 1

- Core 1 \varnothing 50 mm - length 150 mm / Core 2 \varnothing 50 mm - length 90 mm
- The majority of cracks founded were between 0.4 mm and > 1.0 mm, the cores fell apart.
- The depth of cracks were up to the reinforcement steel or in some cases through and through the concrete top layer of c. 250 mm

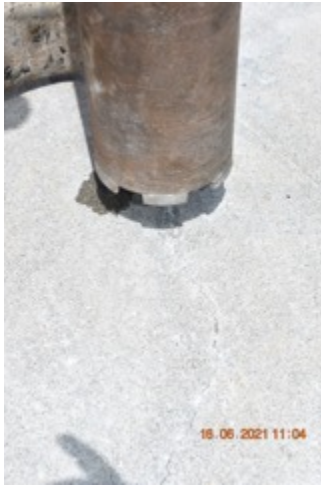
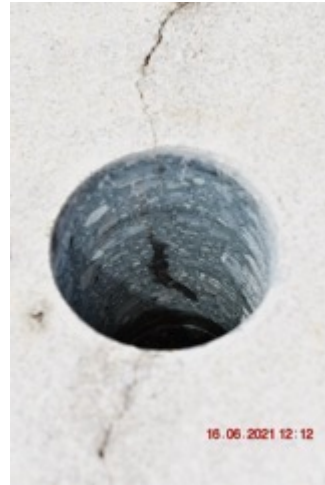
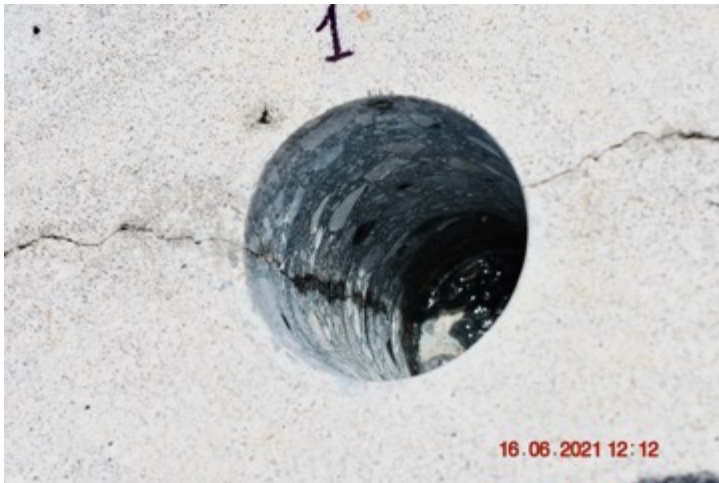
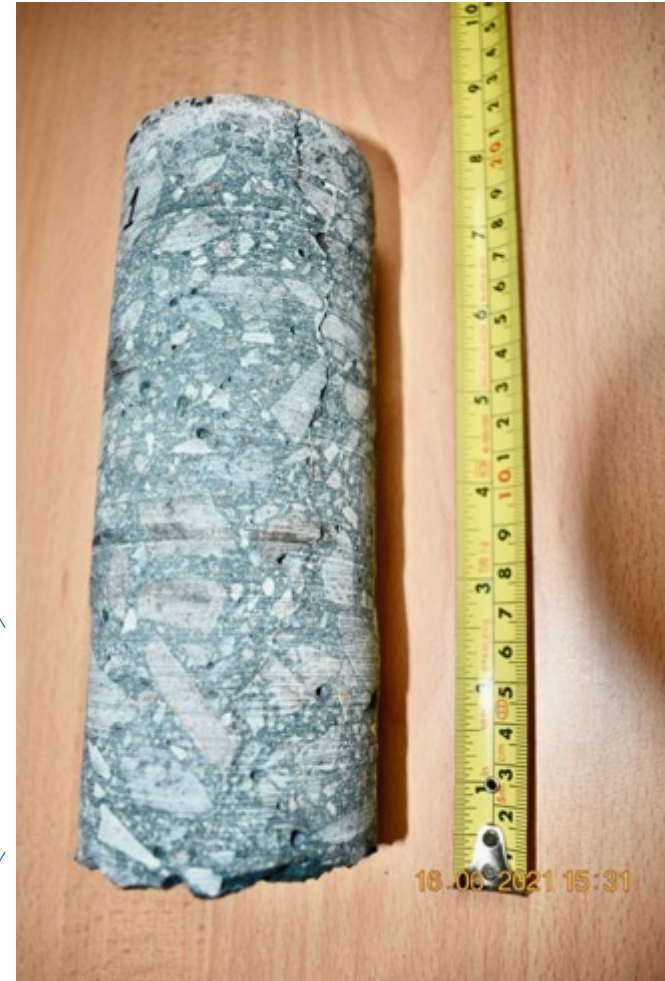
TEST RESULT 2.1.1

- Core \varnothing 50 mm - length 200 mm
- Healing process after 21 days between 10 - 50 mm from the bottom side of the core

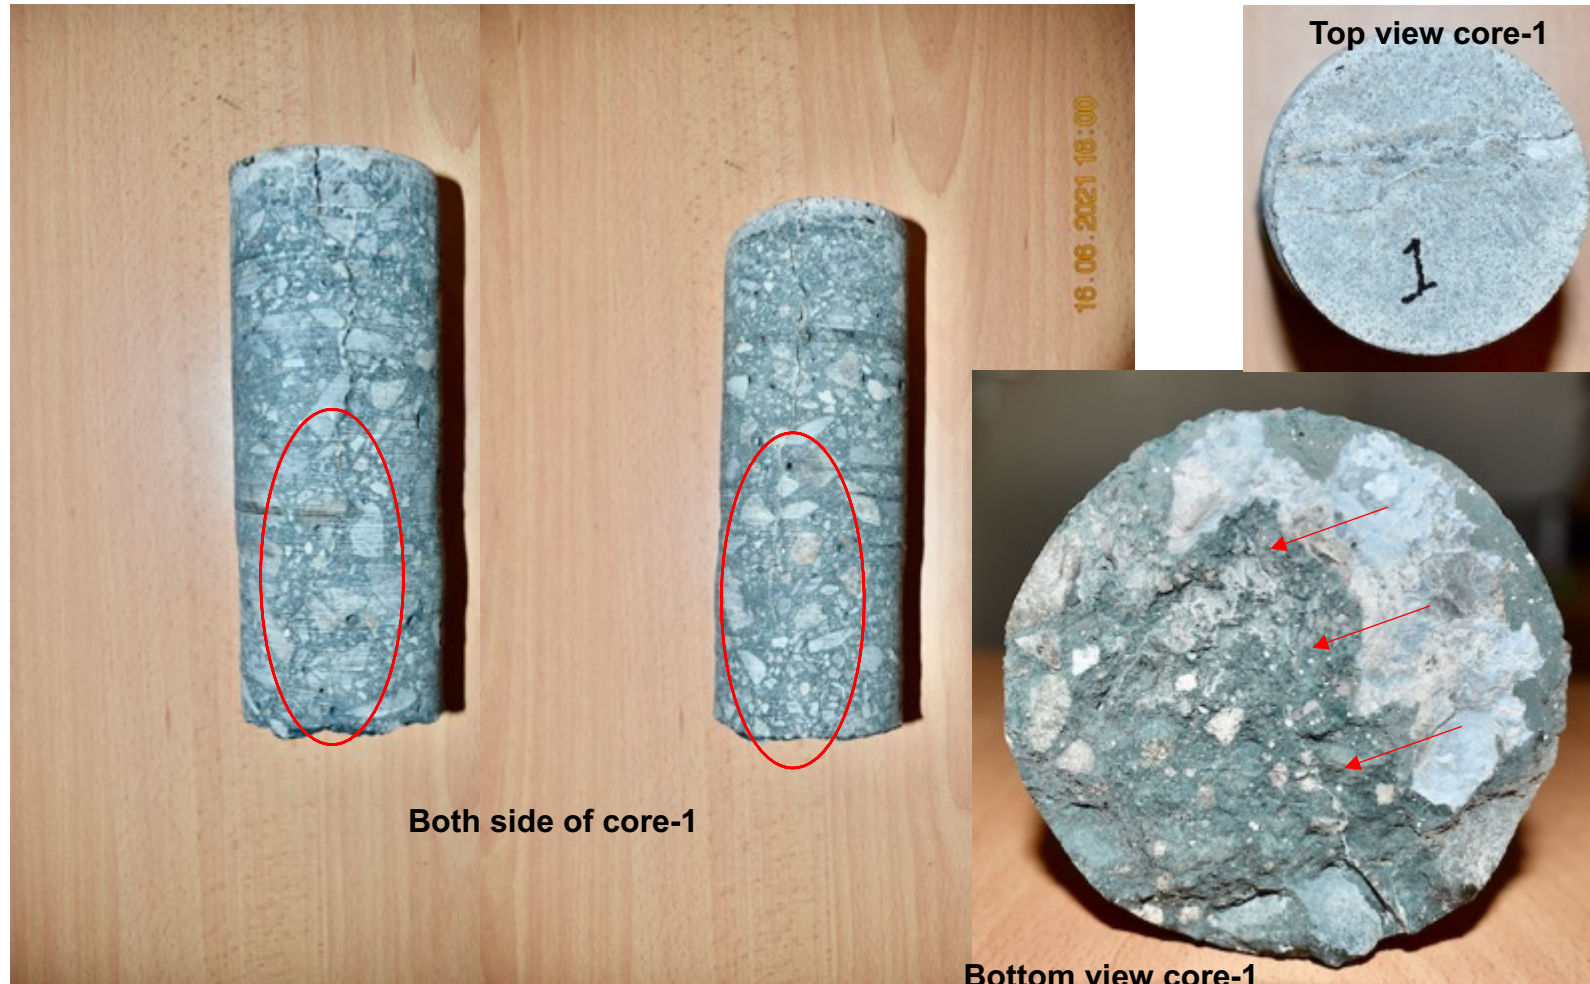
TEST RESULT 2.1.2

- Healing process started, see details core 1 at the bottom side of the core.
- Top view of core 1 shows traces of pollution and calcification in and the around the crack

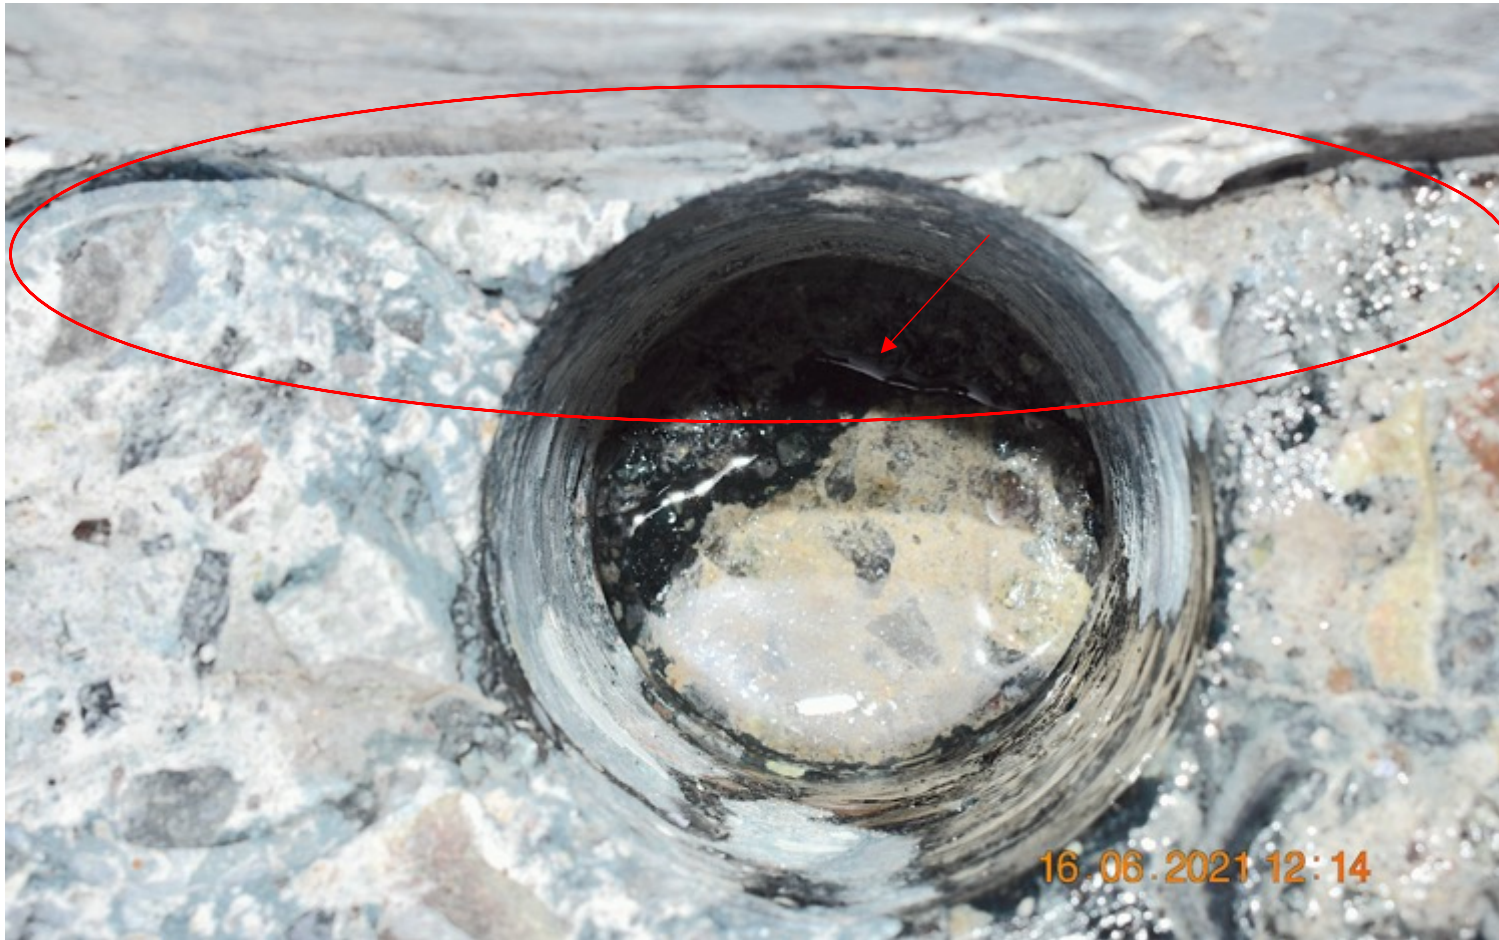
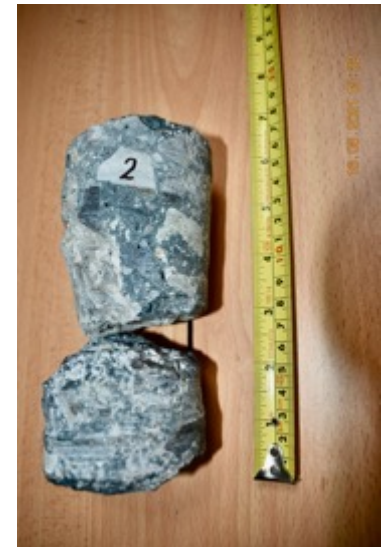
TEST RESULT 2.2.

- Core \varnothing 50 mm - length 180 mm
- Healing process after 21 days between at the bottom side of the core hole, still water-fluid found in core hole
- Cracks are partly healed.
- Core broke in pieces during core drilling, no healing process could be detected

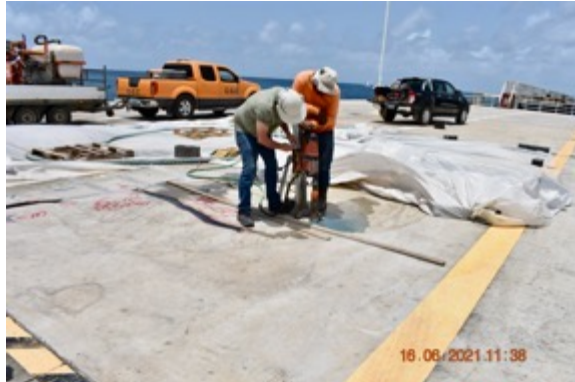
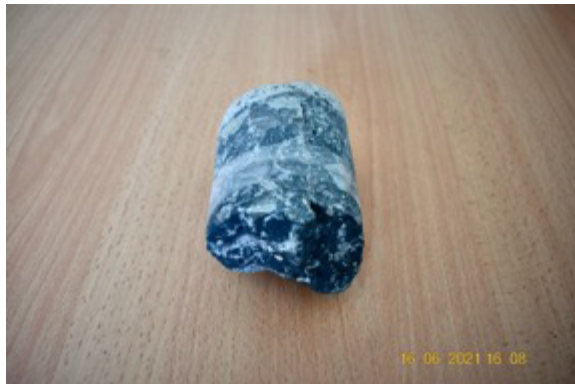
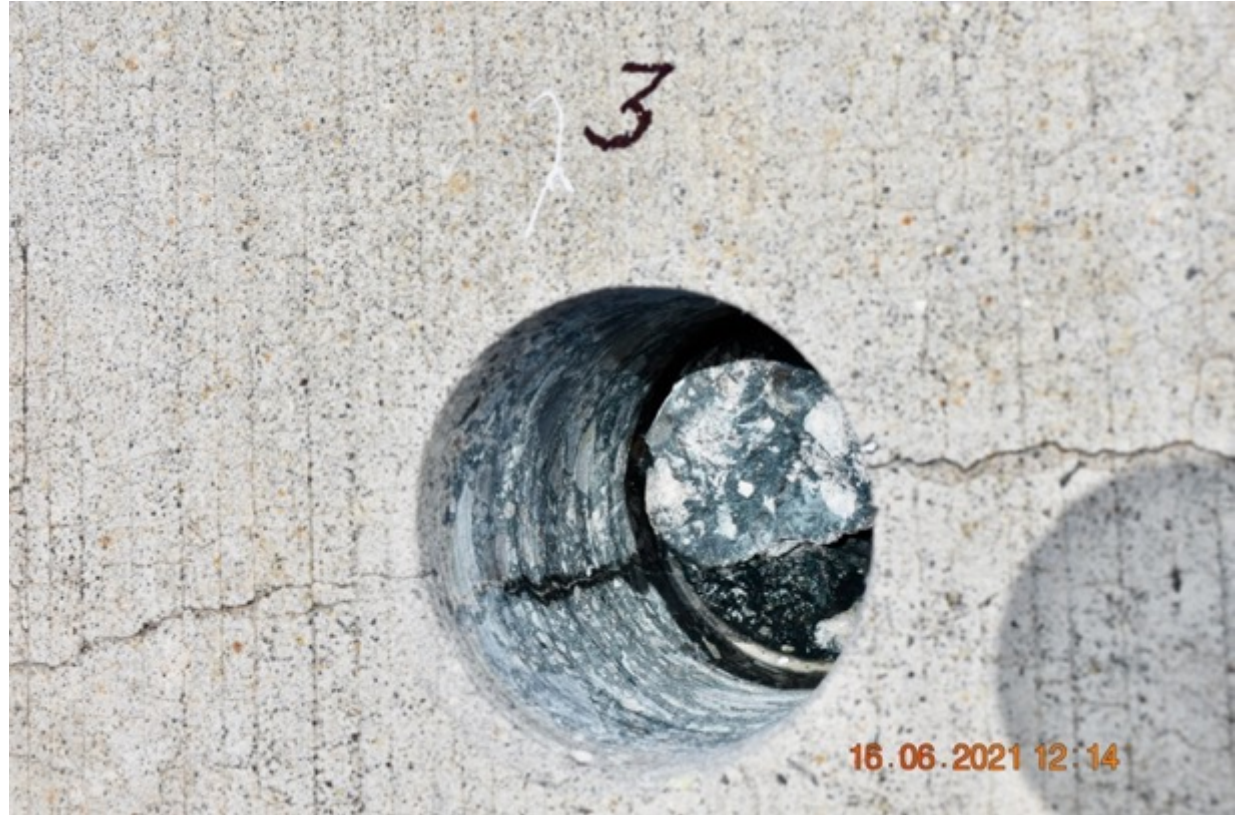
TEST RESULT 2.3.1

Healing process after 21 visual inside core hole noticed, cracks are not fully healed.

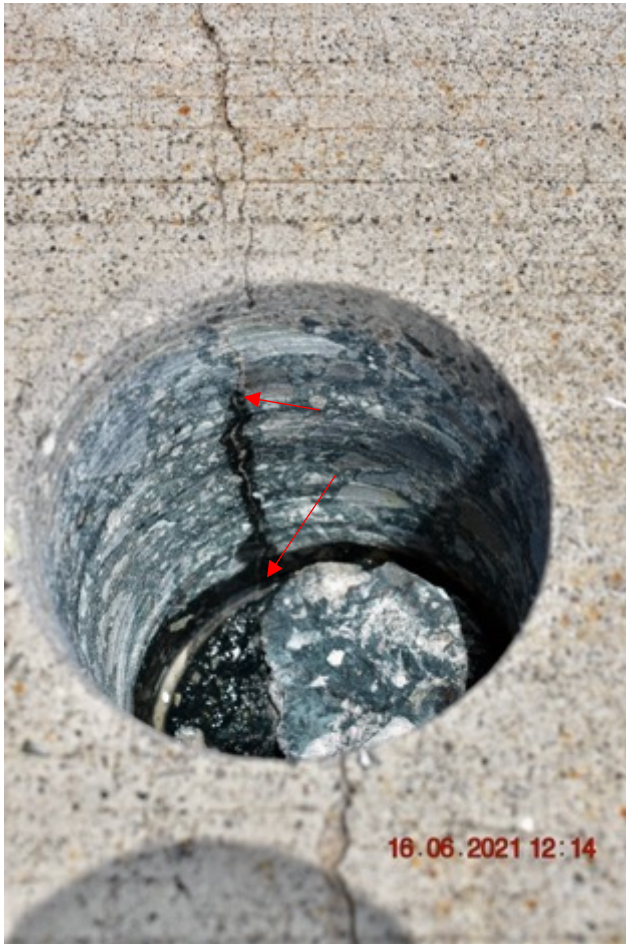
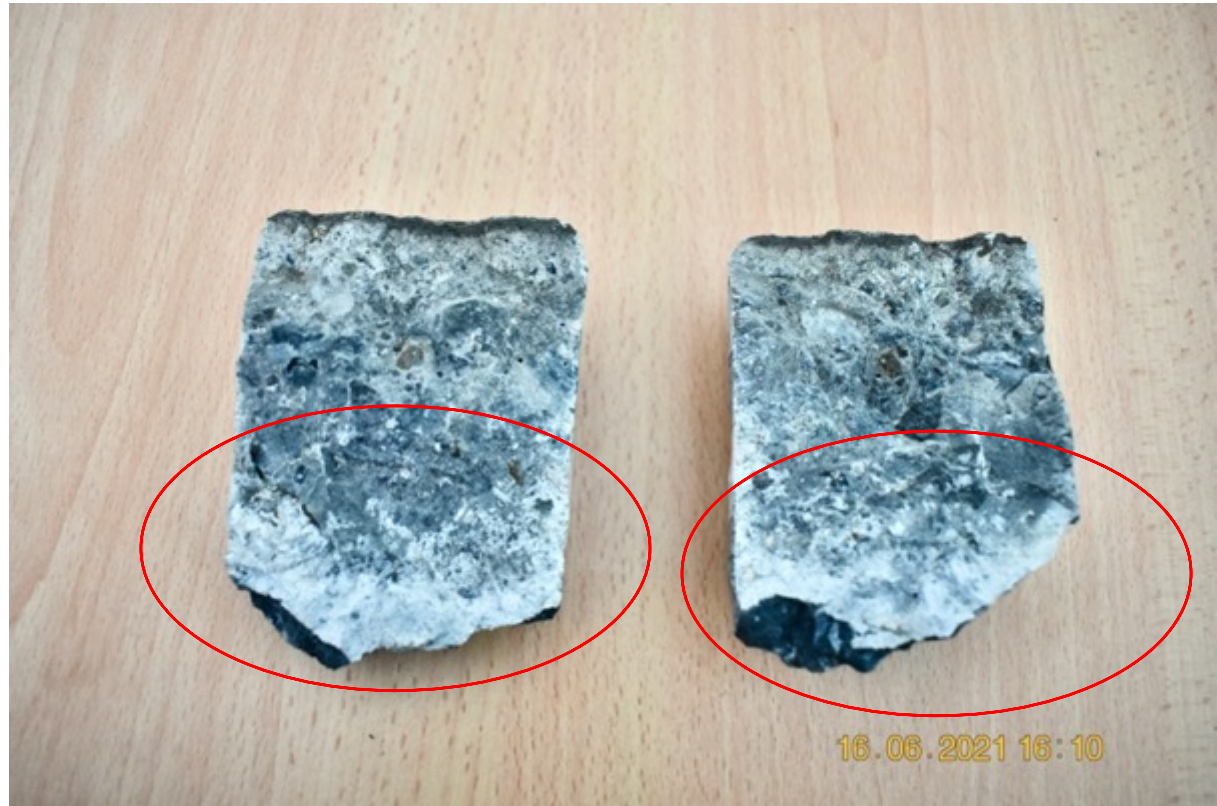
TEST RESULT 2.3.2

- Healing process after 21 days in the core hole noticed
- Core after pressure test split into 2 pieces, see results of the ER7 liquid penetrated in the concrete core sides, which had been spliced on the crack.
- Cracks are partly healed.

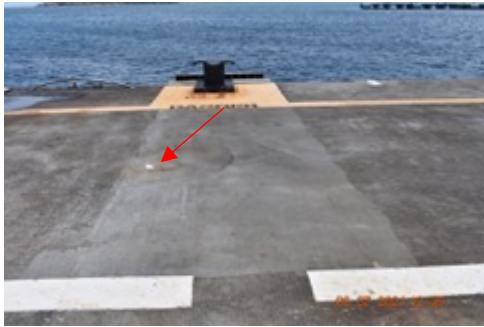
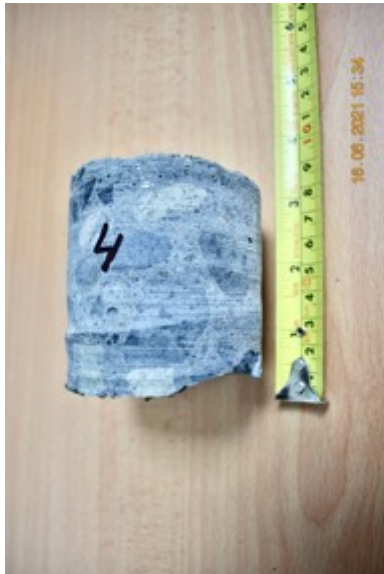
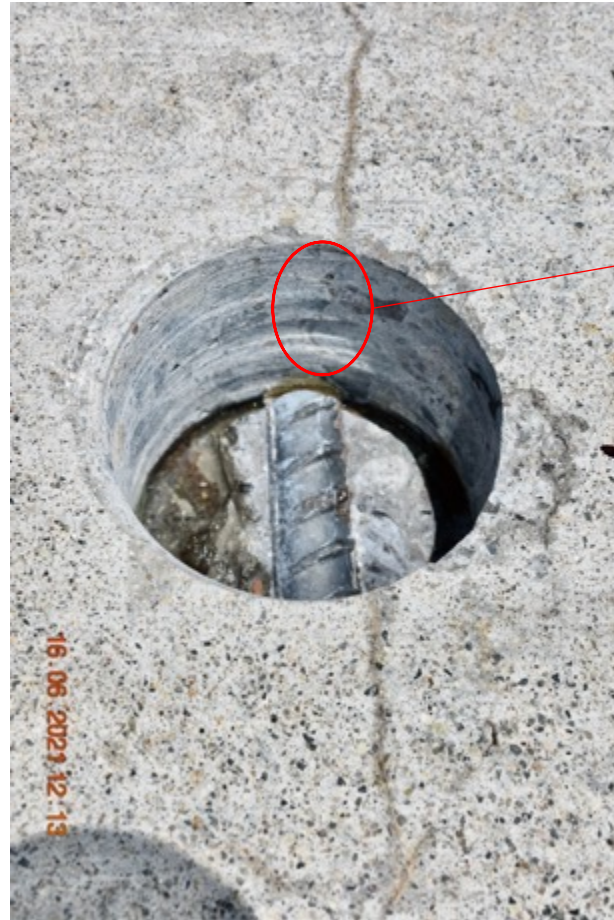
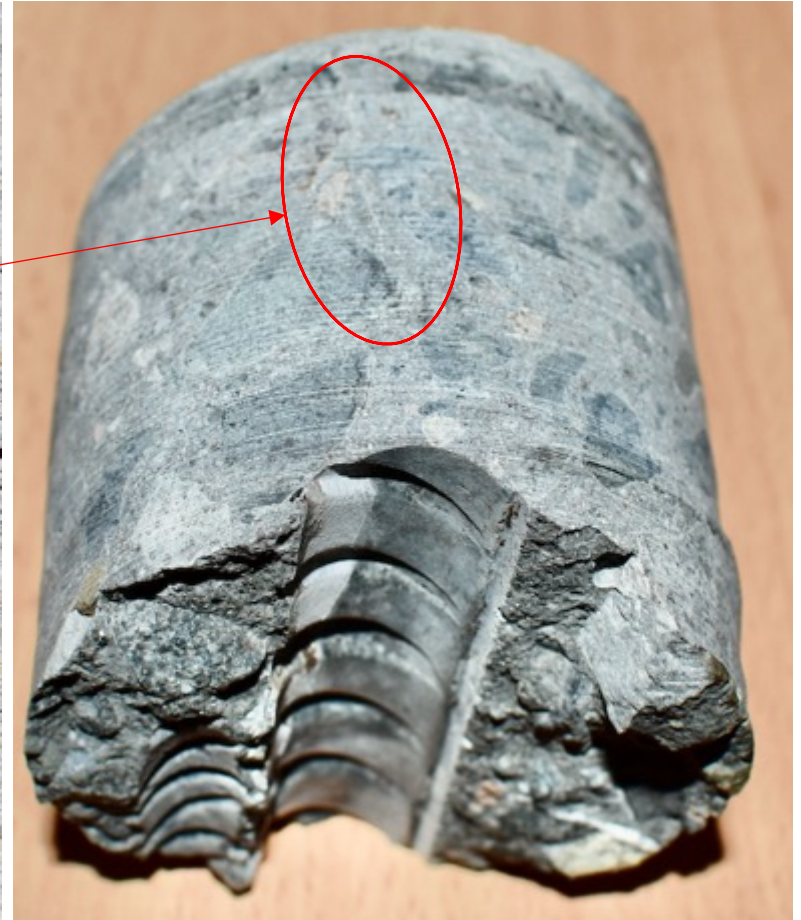
TEST RESULT 2.4

- Core \varnothing 50 mm - length 80 mm
- Location at original pier-deck [first layer] construction.
- Healing process started above reinforcement steel
- Cracks are partly healed

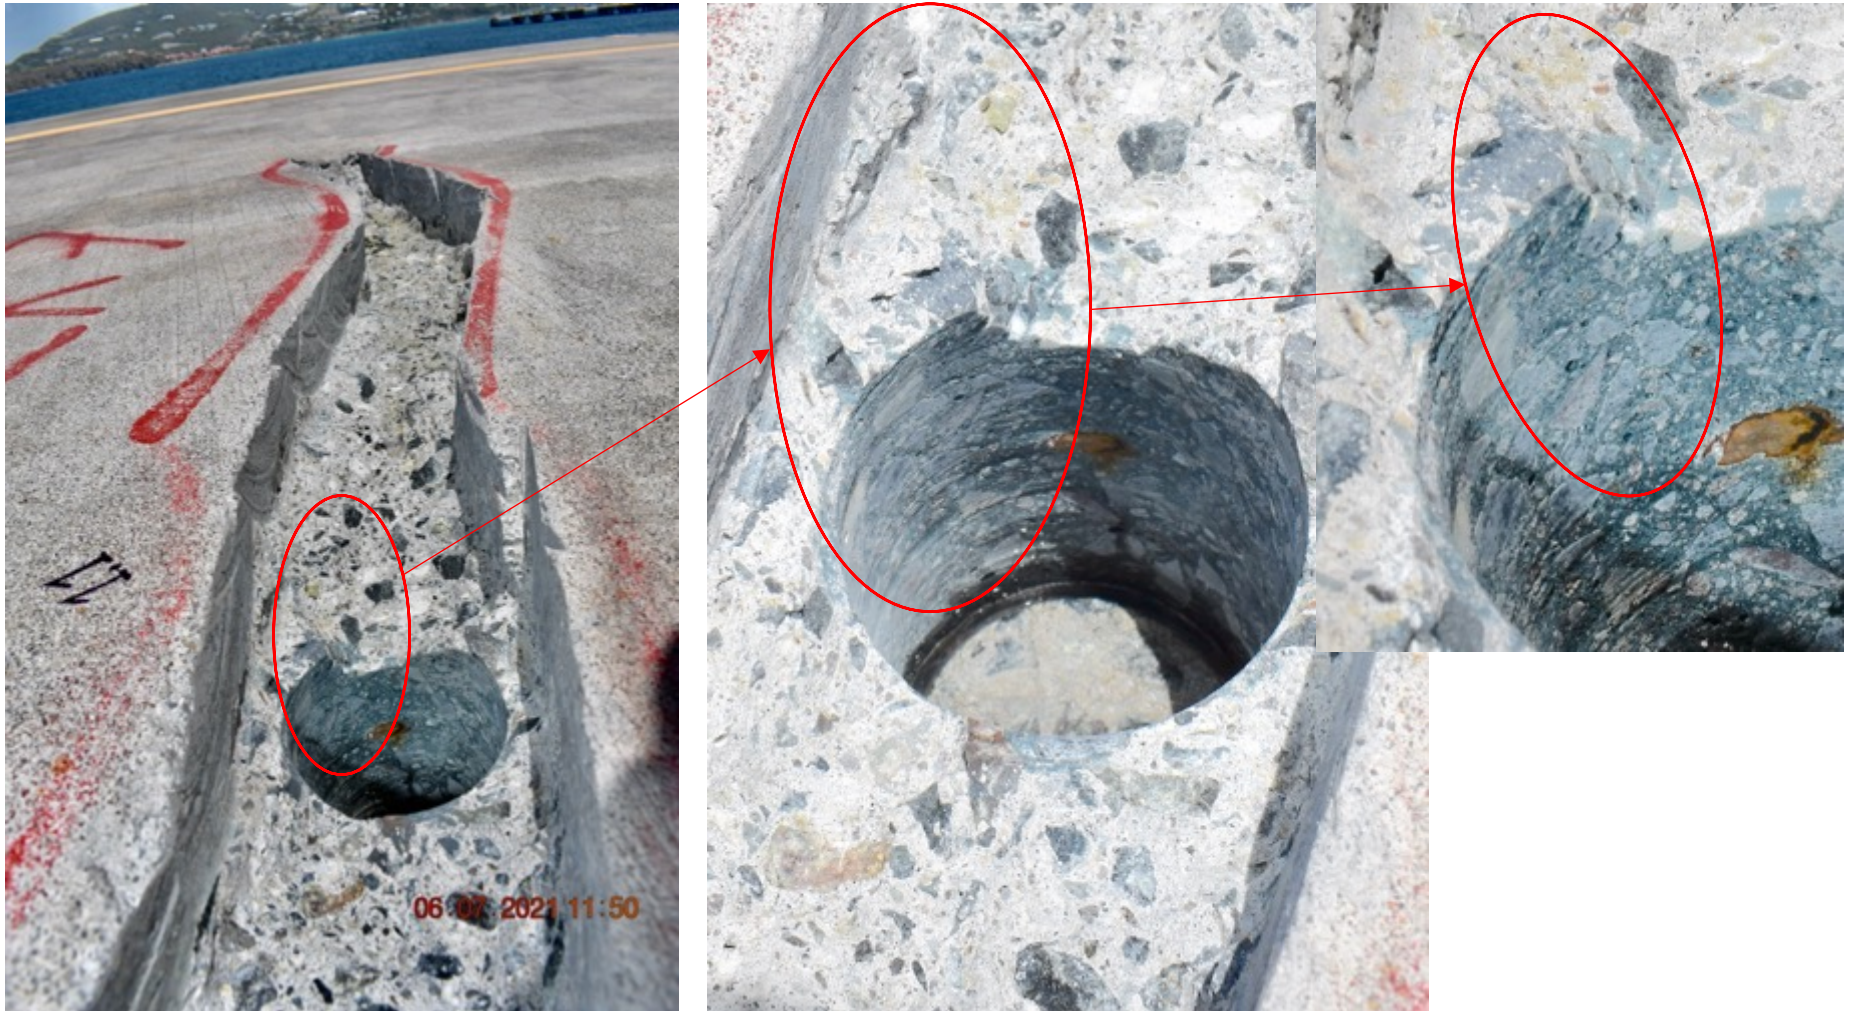
TEST RESULT 3.1

- New Core \varnothing 50 mm - length 180 mm at 60 mm trace depth
- Partly healing process, compaction of porosity surface and crack healing - cracks are partly healed
- Note: trench was almost all 42 days filled with water

- Due to the depth of the cracks and larger crack width, another treatment with ER7 [2nd period of 42 days] is required to further optimize the healing process

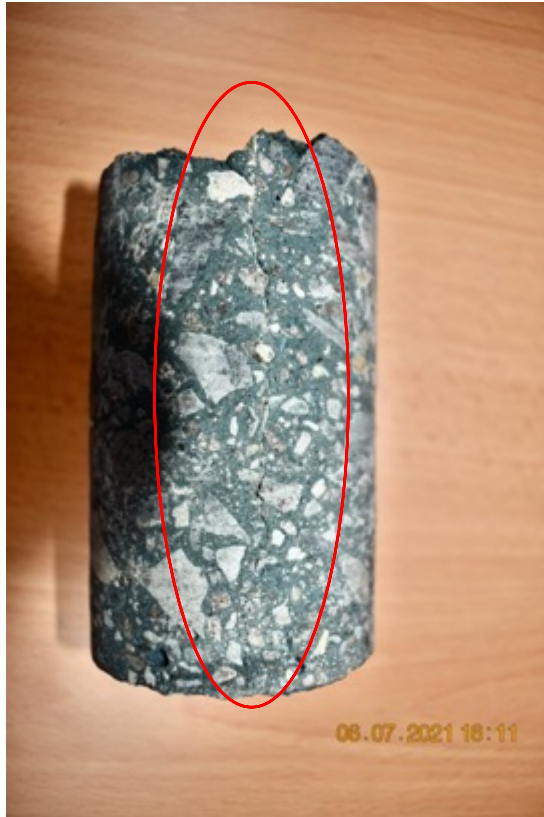
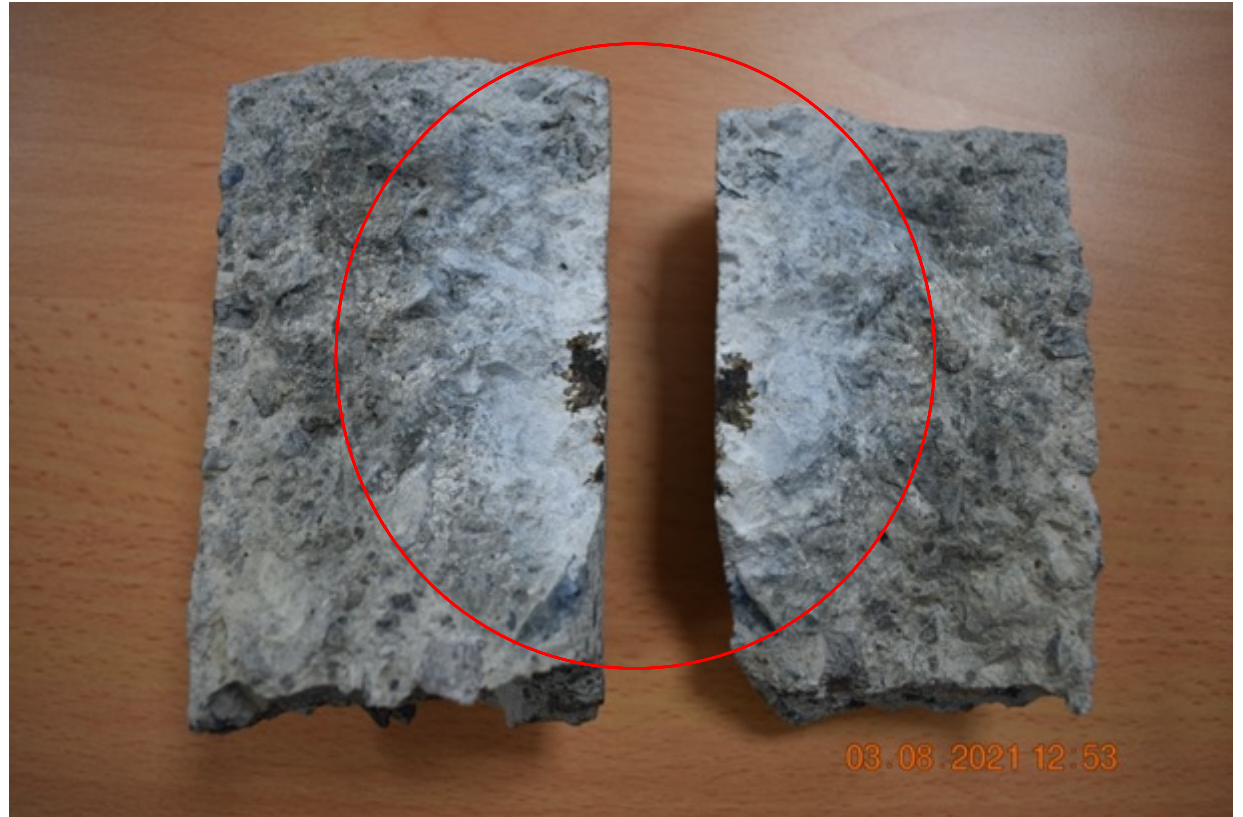
TEST RESULT 3.1

- Partly healing process 42 days
- Core split in two pieces after some minor pressure
- Crack partly healed

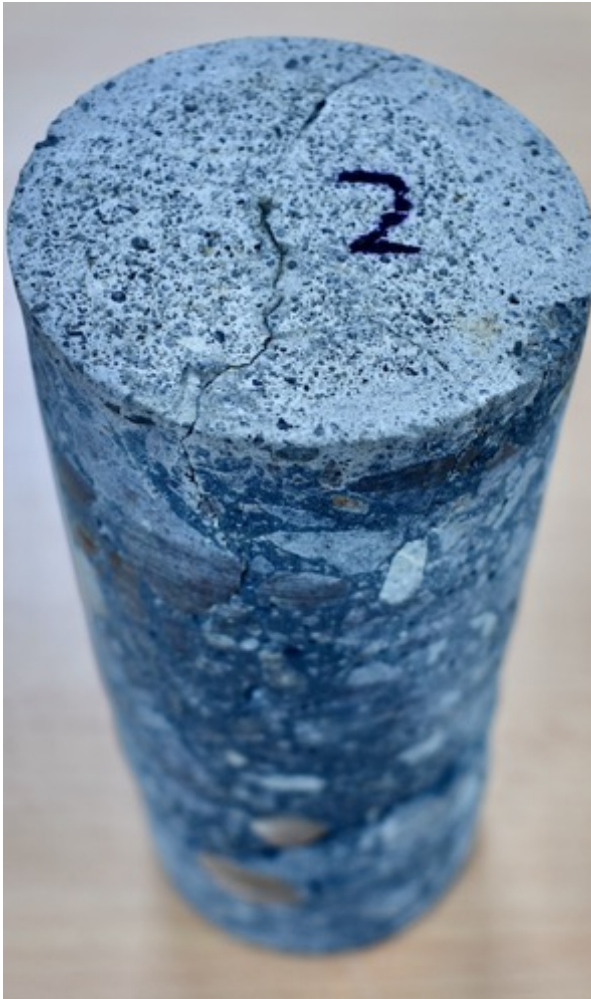
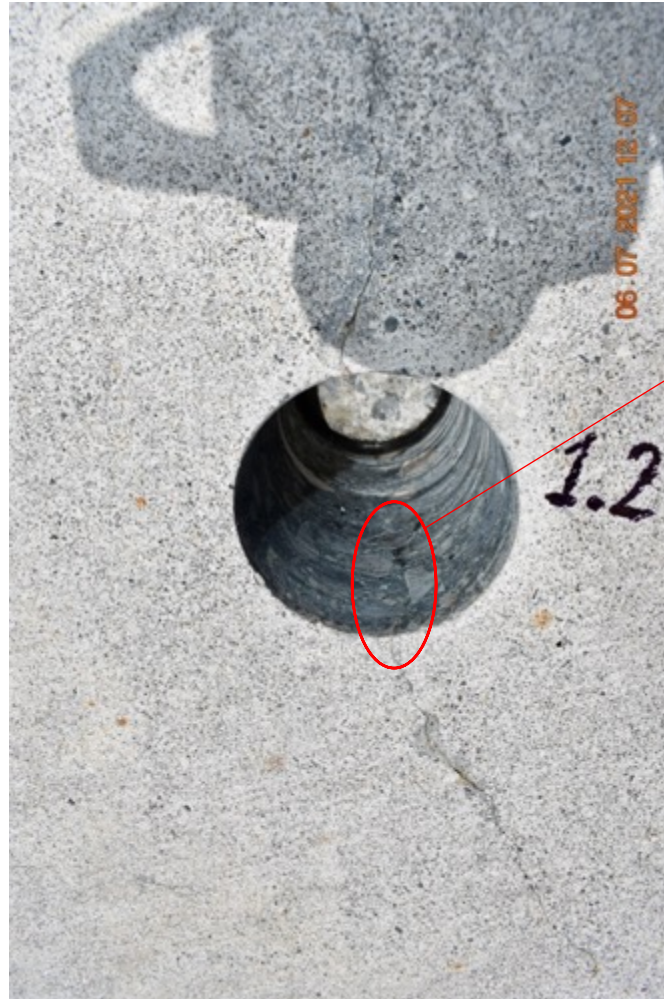
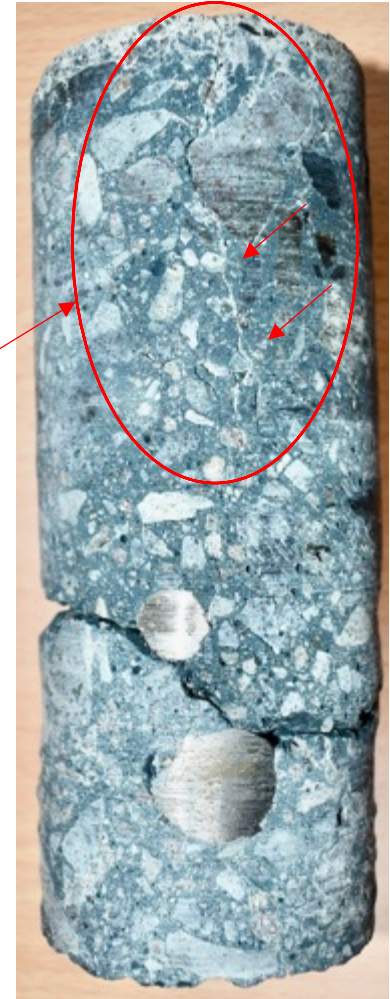
TEST RESULT 3.2.1

- New Core \varnothing 50 mm - length 200 mm
- Location in power washed area and surface treatment.
- Partly healing process - compaction of porosity top layer of the concrete - crack partly healed

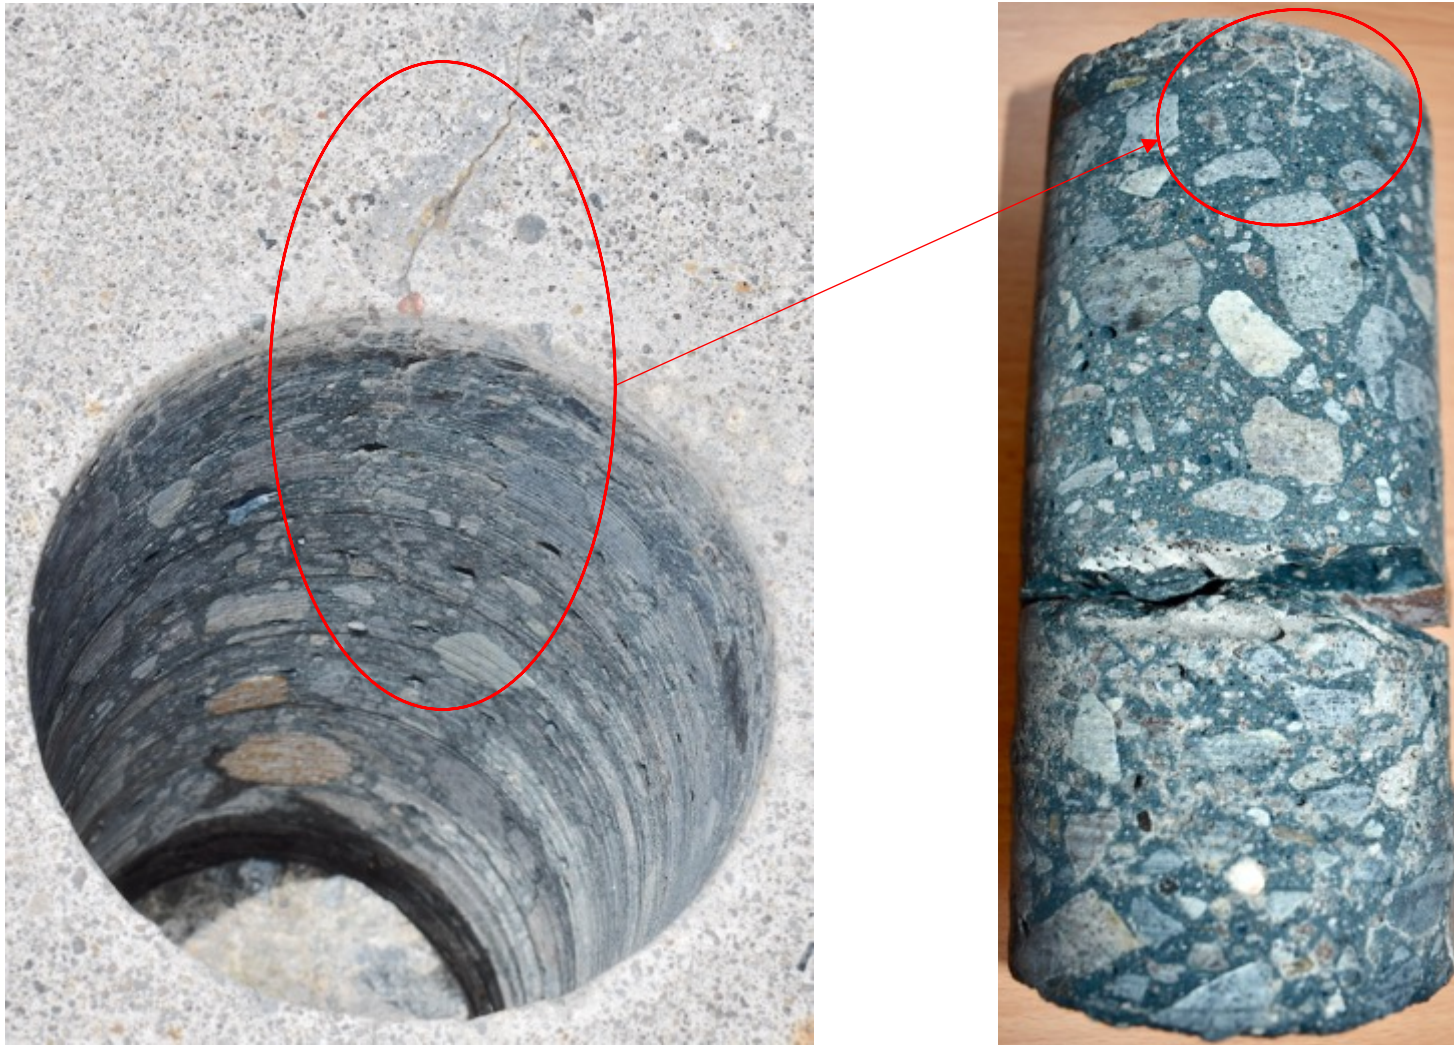
TEST RESULT 3.2.2

- Partly healing process - crack repair from surface area - advanced healing

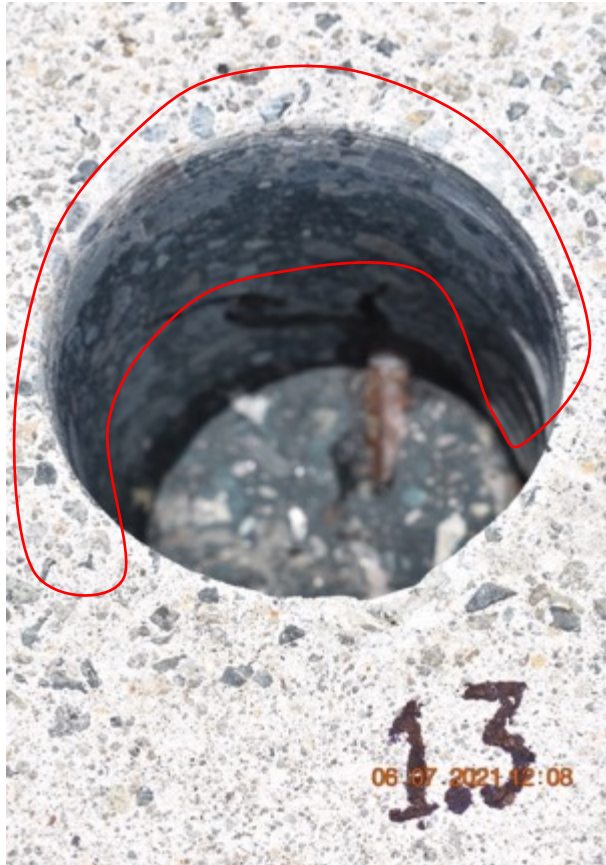
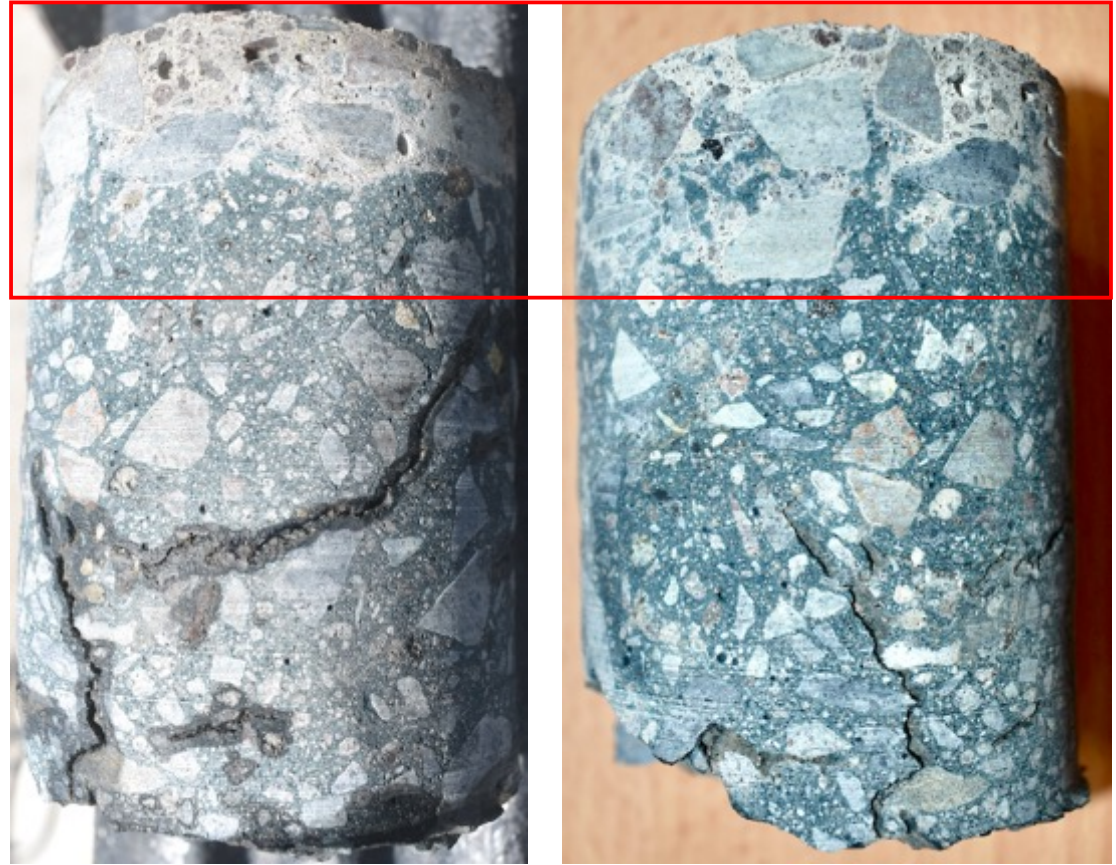
TEST RESULT 3.3

- New Core \varnothing 50 mm - length 100 mm
- Location in power washed area and surface treatment.
- Healing process, compaction of porosity top layer of the concrete

- We have noticed that the porosity of the concrete is quite high
- We have noticed that not visible cracks at the surface have been observed during the drilling of the cores, see;
 - [Test Result 3.3 _ page 17]
- The whole crack pattern is concerning with possible constructive consequences

- In regard of possible constructive consequences, it is recommended to arrange a further constructive review by a Structural Engineer.

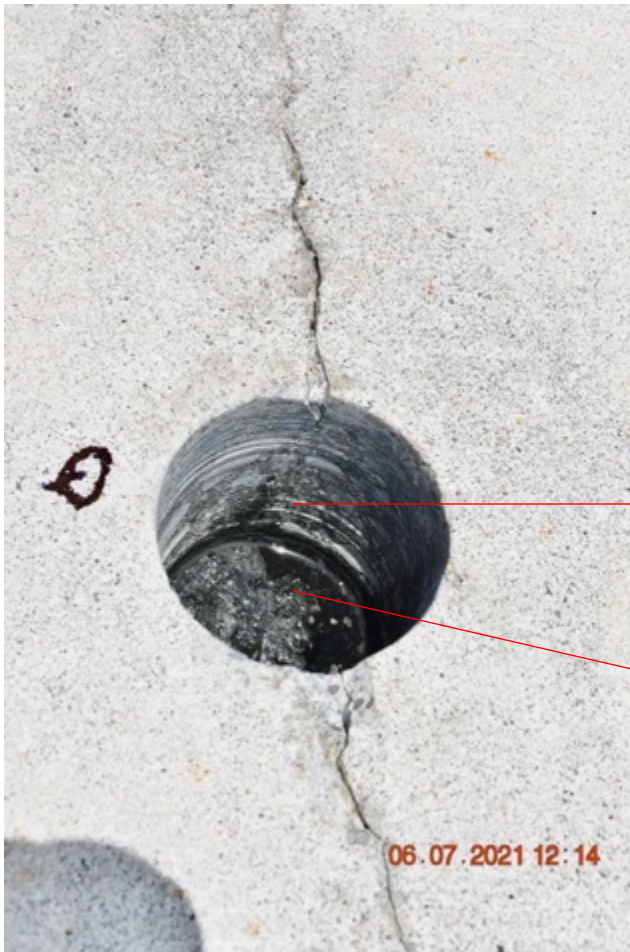
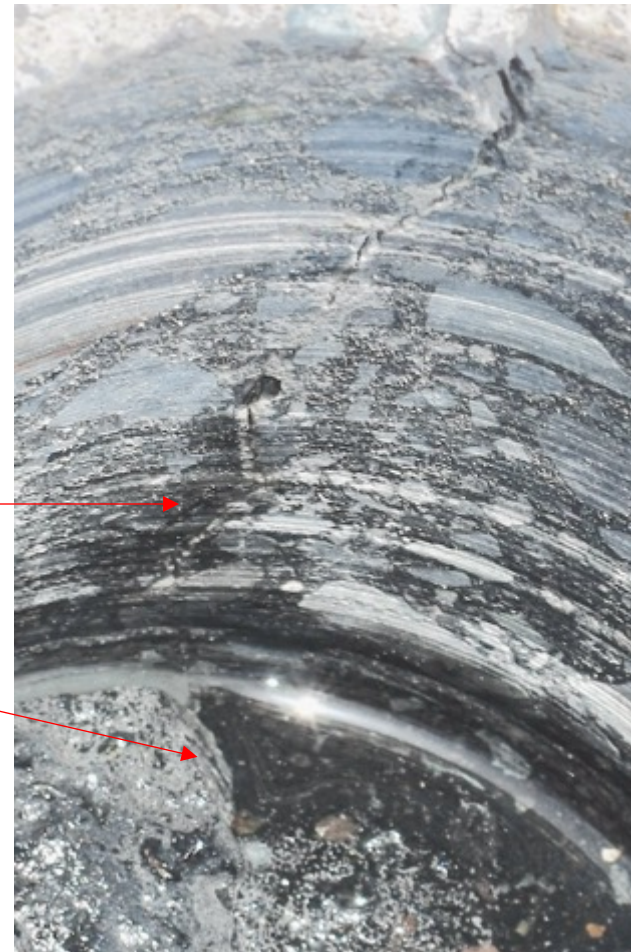
TEST RESULT 4.0

- See Test Result 1 - page 6
- Continue healing process
- Cracks partly healed

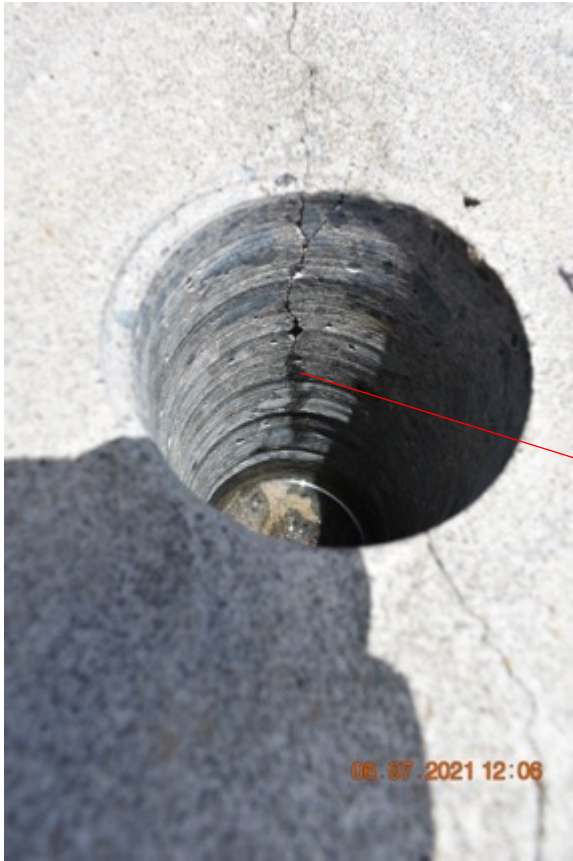
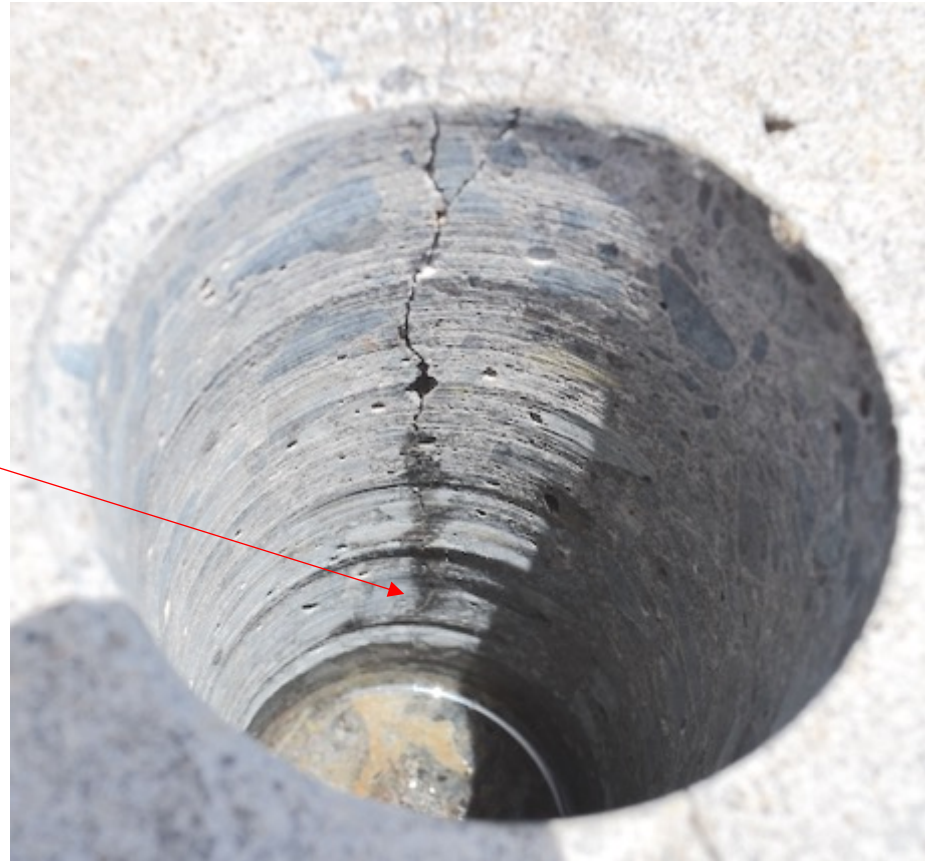
TEST RESULT 4.1

- See Test Result 2.1 - page 7, 8
- Continue healing process
- Cracks partly healed
