TEST RESULTS 1st SELF HEALING PERIOD

PROJECT REPAIR TOP DECK CRUISE PIER

With Self-Healing Concrete Solutions

Project no.: BC-2021-001

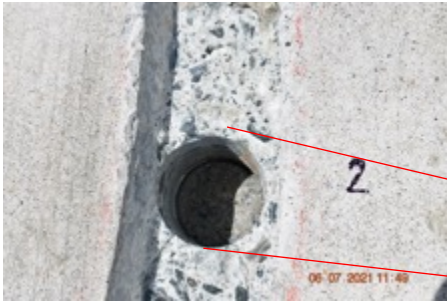
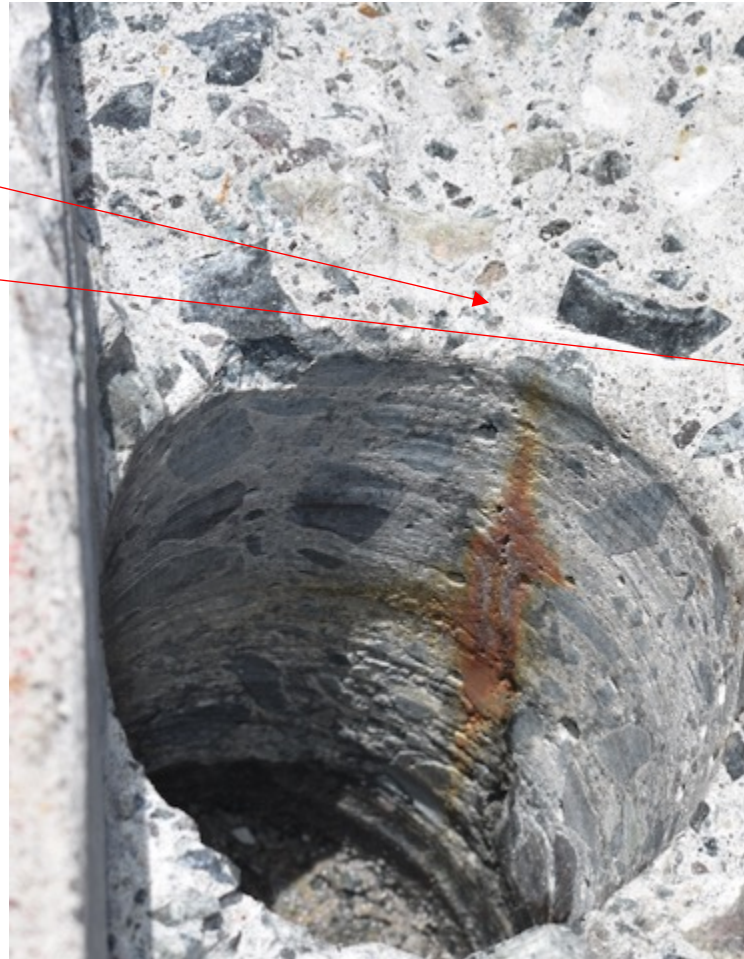
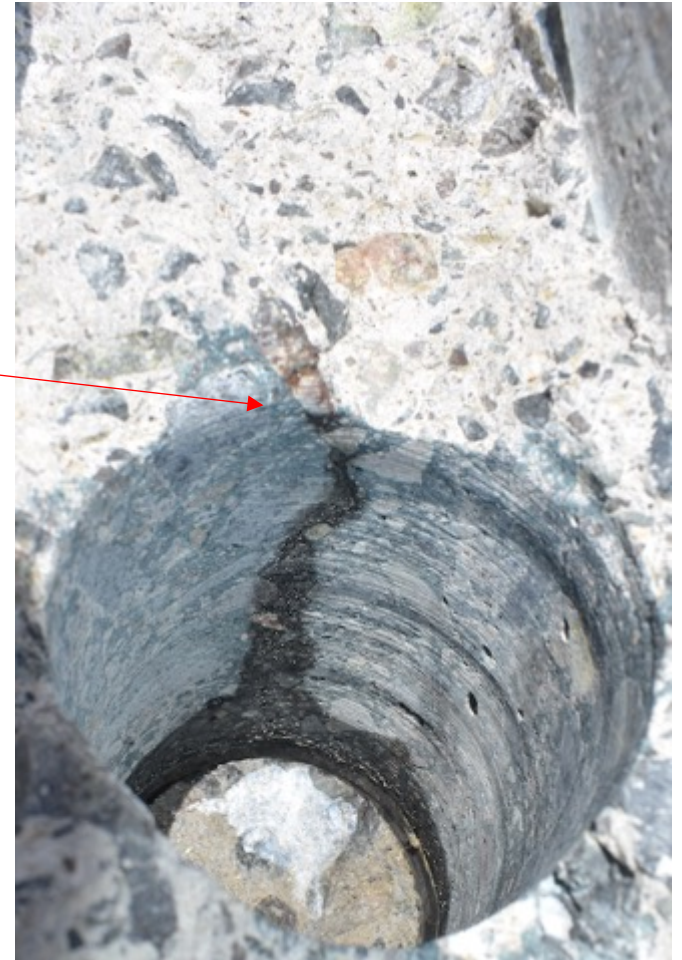
TEST RESULT 4.2

- See Test Result 2.2 - page 9
- Continue healing process
- Cracks partly healed
- Surface healing noticed
- Trench was full of water before inspection

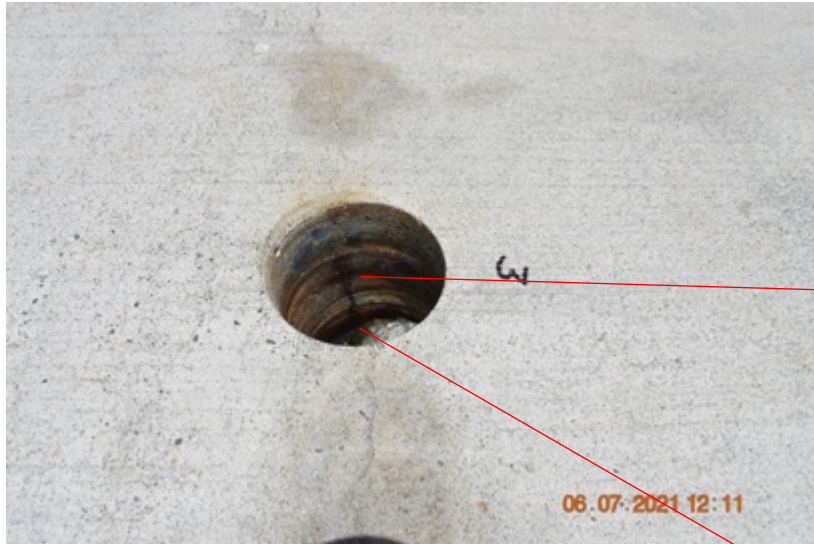
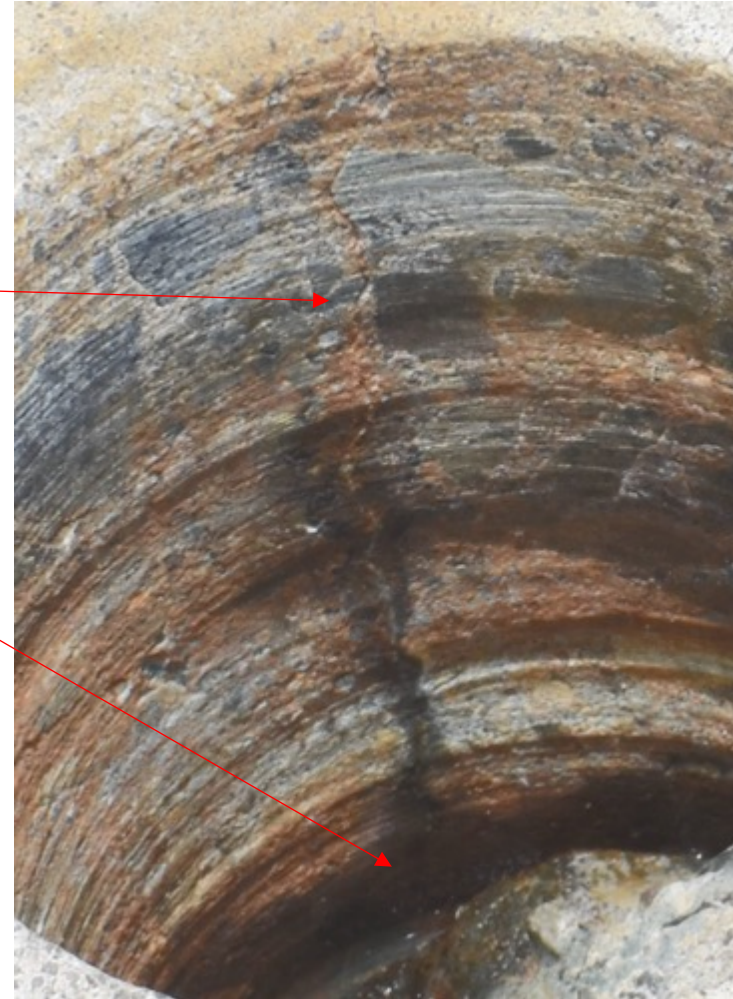
TEST RESULT 4.3

- See Test Result 2.3 - page 10, 11
- Crack partly healed
- Comparable to Test Result 2.3

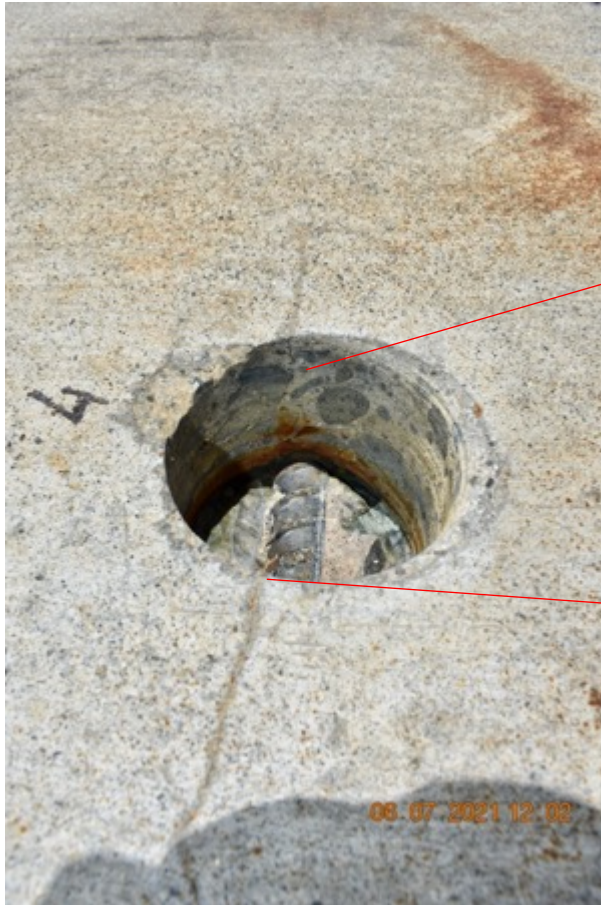
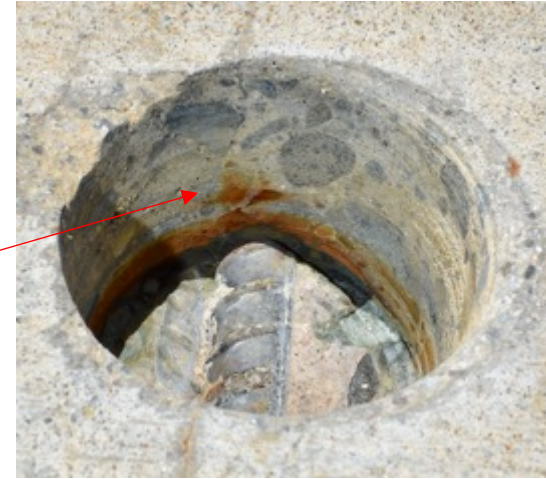
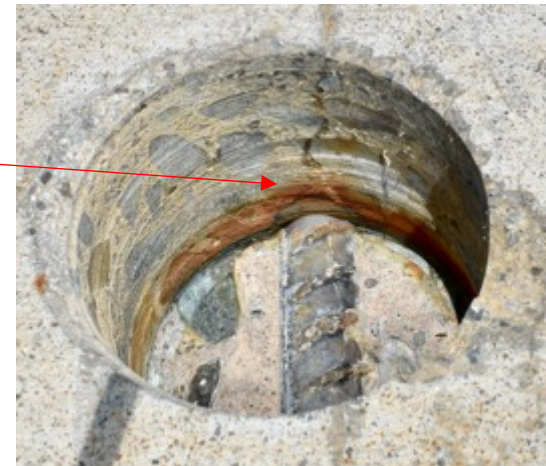
TEST RESULT 5

- See Test Result 2.4 _ page 12
- Location in power washed area old original concrete deck which is heavily contaminated
- Cracks partly healed

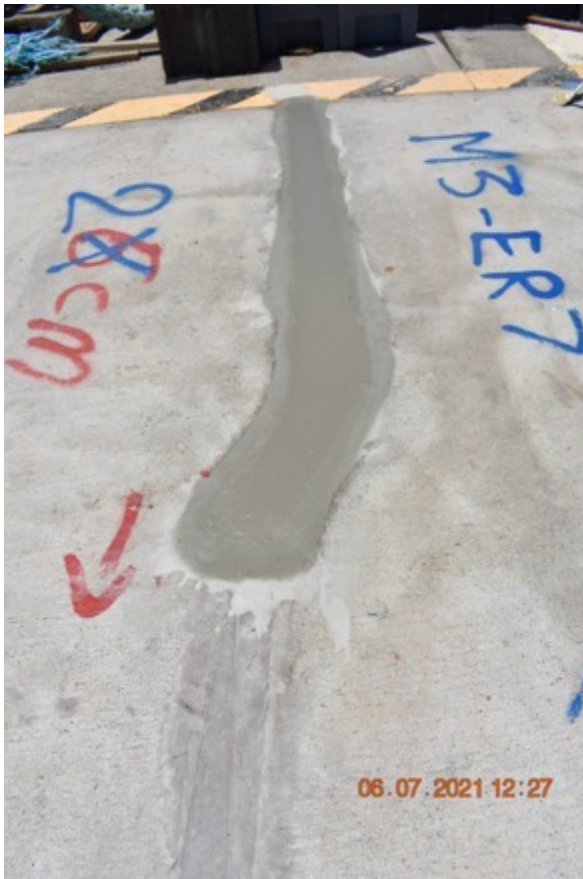
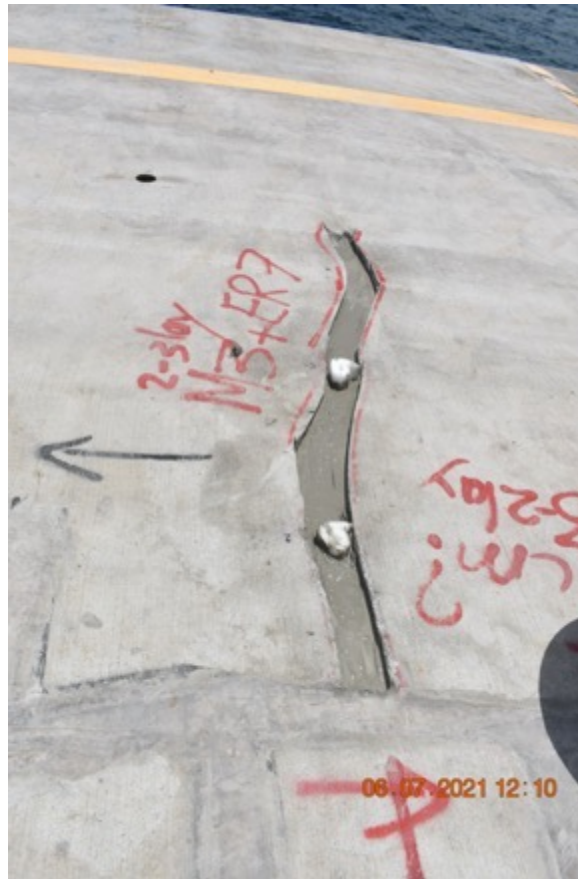
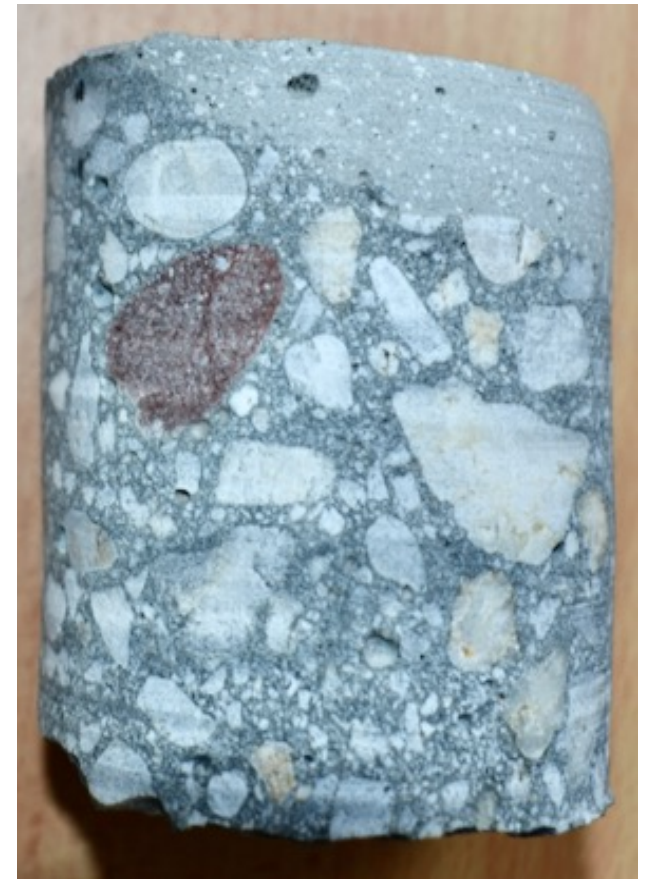
TEST RESULT 6

- MR3 trench repair of 20 mm & 30 mm:
- MR3 trench repair of 60 mm:
- ER7 & MR3 trench repair of 60 mm:

Application with 1 layer of MR3 mortar

Application with 2 layers of 30mm MR3 mortar

Application of 1 treatment of ER7 and 2 layers of 30mm MR3 mortar

- The repairs with the MR3 repair mortar shown a fully homogenous repair result
 - [Test Result 6 _ page 20]
